# COMPREHENSIVE BEAVER MANAGEMENT PLAN MERRIMACK, NEW HAMPSHIRE

May 15, 2015

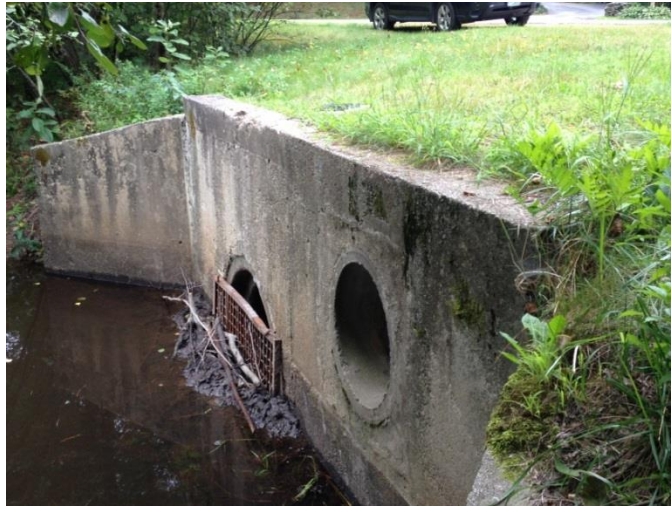
View of beaver damming at a culvert associated with Hanson Drive.

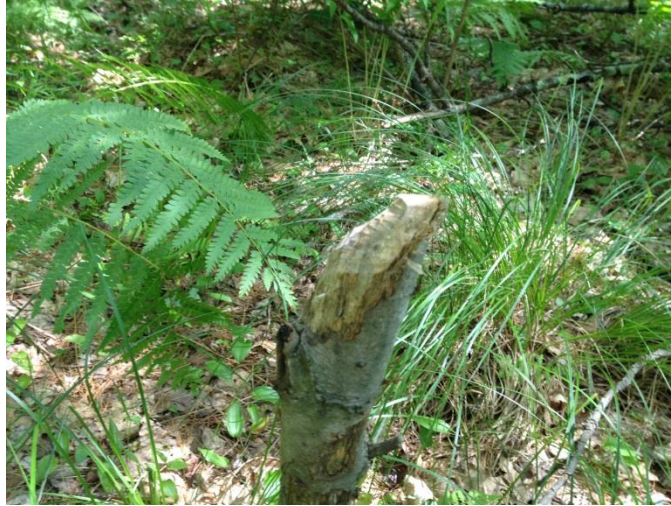
Area 2 contained many tree stumps cut by beaver. Most of the stumps appeared to be older cuttings. There was no evidence of current dams, lodges, or food piles directly downstream of Area 2. However, this area is located in close vicinity to five other known problem areas, four of which exhibited recent beaver sign. Area 2 is located within a high habitat suitability area and should be monitored at least annually as part of road maintenance activities.

View of cut tree stump in Area 2.

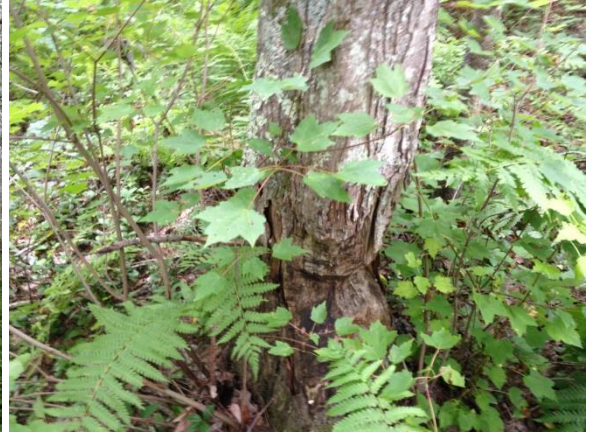
Area 3 is a previous location of beaver damming activity. In addition, the site has evidence of flooding and tree damage. During 2014, there was no evidence of current damming by beaver near the culvert. However, the floodplain contained old tree cuttings created by beaver. Area 3 is located in a High Habitat Suitability Area. Although the high dominance of white pine in the area might reduce the likelihood of this area serving as a core habitat area, Area 3 is located in a stream corridor with existing beaver populations. Similar to other sites, this area should be reviewed annually to determine current beaver activity over time.

View of old tree cuttings started by beaver.

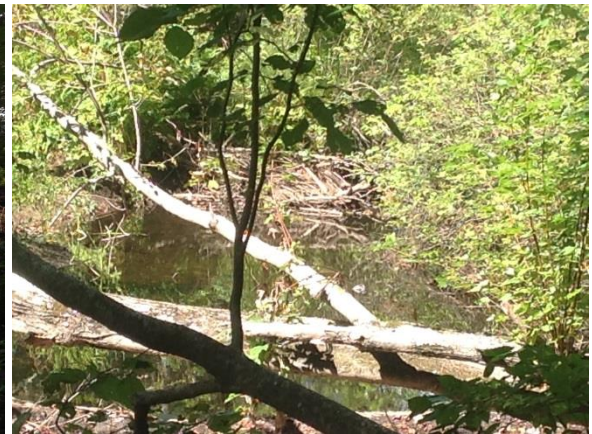
Area 5 contained a series of old beaver dams but lacked new tree cuttings or fresh mud on old dams during the summer of 2014. Based on landowner testimony, there was no obvious beaver activity in this area during the spring of 2014. Although there are no current conflicts, this area functions as a possible recolonization site.

View of old beaver dams at Area 5.

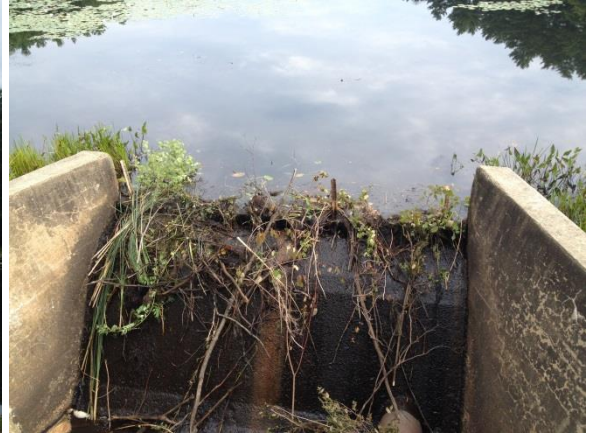
View of the Stump Pond spillway.

A small (10-foot-long by 2-foot-wide) beaver dam was observed at the concrete spillway of the Stump Pond Dam. Currently, beaver activity does not appear to be causing significant flooding or maintenance concerns. Additionally, during the summer, the outlet stream had very little flow and was essentially stagnant.

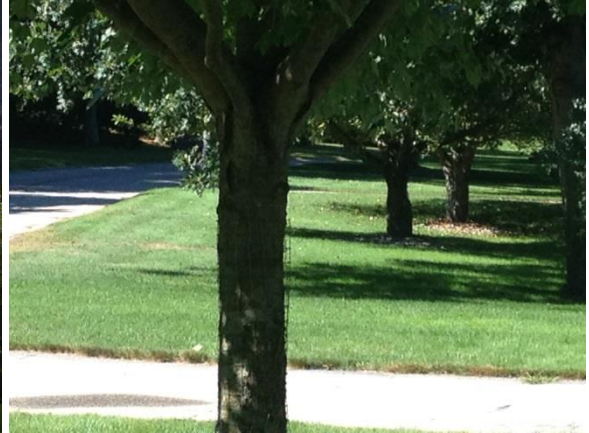
Local residents have installed tree guards to limit tree cutting and damage by beaver.

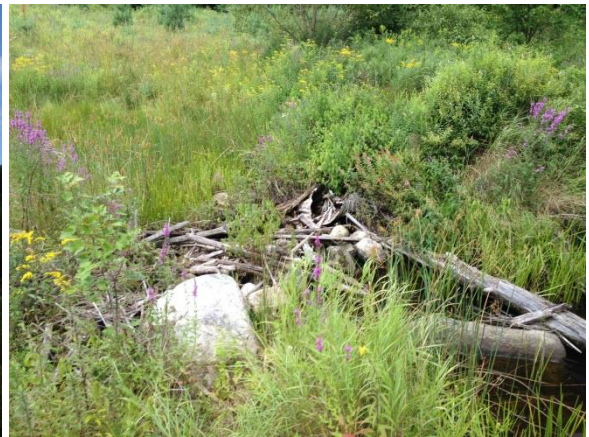
Area 9 is located in the Grater Woods Conservation Area. The area is a previous beaver pond. The failure and breaching of a small beaver dam (approximately 12-feet long by 4-feet wide) led to the complete draining of the prior pond. The area currently consists of a small stream meandering through a wet meadow. The wet meadow is classified as a palustrine emergent system that is seasonally saturated (PEM1E). The upland forest surrounding the wet meadow is dominated by white pine, in association with red maple. The dominant plant species in the herbaceous layer are wool grass, goldenrod (*Solidago* spp.), and broad-leaved cattail. Other species present include meadowsweet, false nettle, dark green bulrush, and rattlesnake grass. Small areas of yellow spatterdock and bur-reed are also present along the stream. Purple loosestrife, an invasive plant, is also present.

View of the abandoned beaver dam at Area 9.

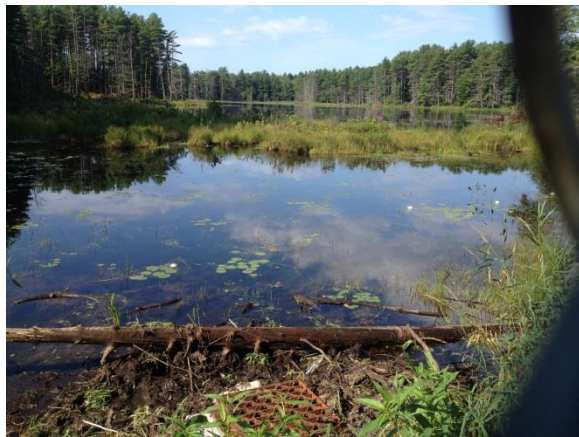
The drop inlet associated with the Greens Pond Road showed evidence of previous management. Two abandoned beaver dams were also observed in Naticook Brook, downstream and northeast of Greens Pond Road. As beaver activity increases again in this area, a protective device will likely be needed at the drop inlet to prevent weekly regular maintenance.

View of the Greens Pond drop inlet from Greens Pond Rd.

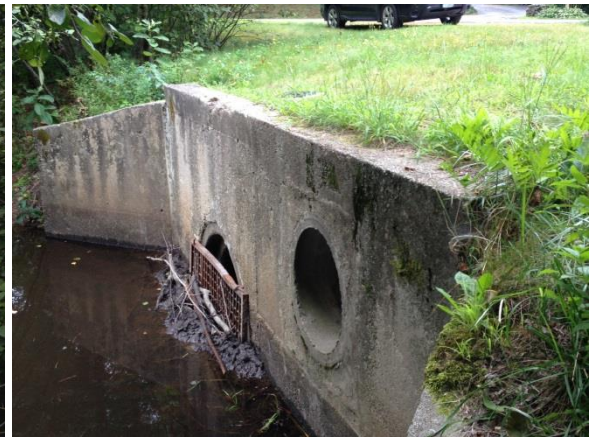
View of culvert damming at Hanson Drive.

Two beaver dams were documented at Area 12, including an actively maintained 5-foot long dam at the first culvert crossing and a second 10-foot long abandoned dam at the second (northerly) culvert crossing. Although abandoned, fresh beaver tracks were observed at the second crossing. At the time of the assessment, the second culvert lacked flow. Over the course of the summer, beaver activity increases at the southerly culvert crossing, which contained a grate to prevent complete damming of the culvert. This area was targeted as a potential area for a water flow device due to the weekly culvert maintenance required at this crossing.

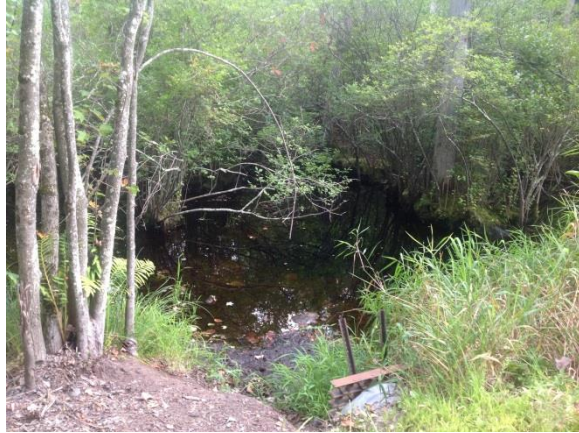
scrub-shrub wetland system to an adjacent detention pond known as Area 30. During 2014, no beaver activity was observed at the Area 14 culvert, although beaver activity was observed nearby in Area 30.

View of Area 14 culvert and protective grate.

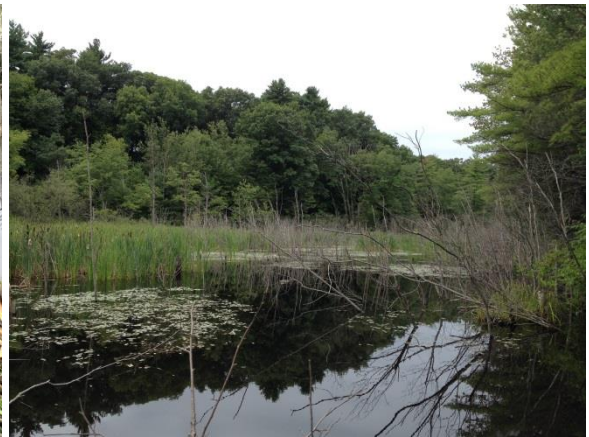
View of beaver pond located directly adjacent to Mast Road.

Although nearby road culverts do not have signs of recent beaver activity, the presence of a beaver dam directly adjacent to Mast Road is causing flooding at a utility pole and represents a potential hazard to the road, should the dam fail. A water flow device may be necessary to control the water elevation of the pond near the road. The presence of a second channel located west of Area 17 presents another possible future conflict area.

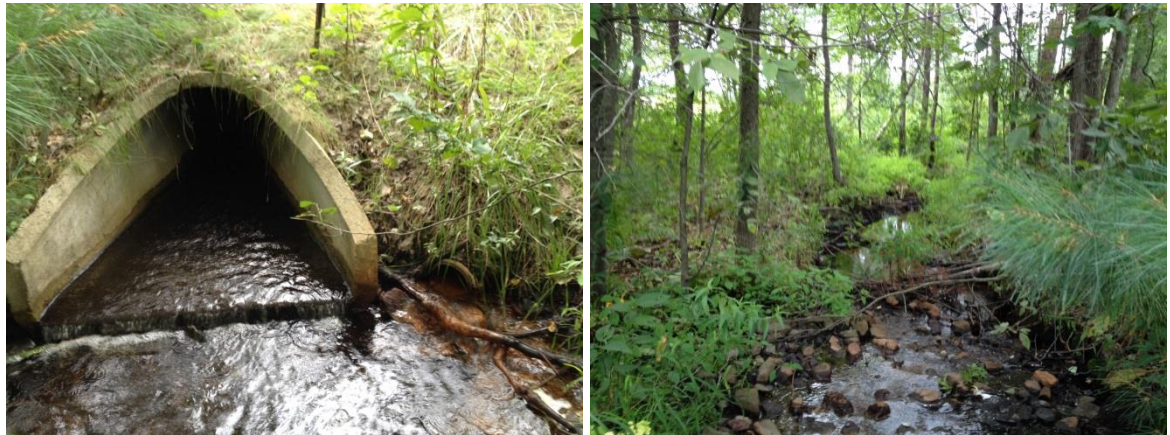
View of culvert and stream located on Mast Road that function as potential beaver dam sites.

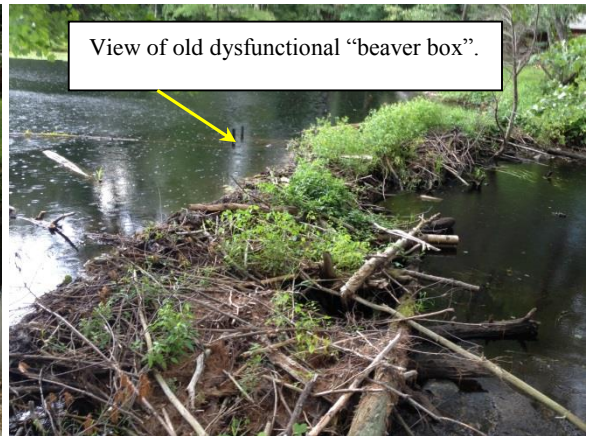
View of primary beaver dam.

Area 18 has been the source of concern for residents bordering the pond. Dam construction by beaver has caused flooding in at least one yard, and beaver have felled large trees in adjacent yards. One owner requested immediate action to limit impacts to her property and the Dam Bureau directed the Town to prevent damage by beaver to the sewer line. Although the Town had installed a "beaver pipe" to maintain water flow in the primary dam, the pipe was routinely plugged by beaver and was not functioning. Due to landowner concerns, as well as a need to protect the sewer line infrastructure, Area 18 was considered a high priority area for management activities. A proper water flow device, as well as a protective fence for the drop inlet structure was installed at Area 18 during 2014.

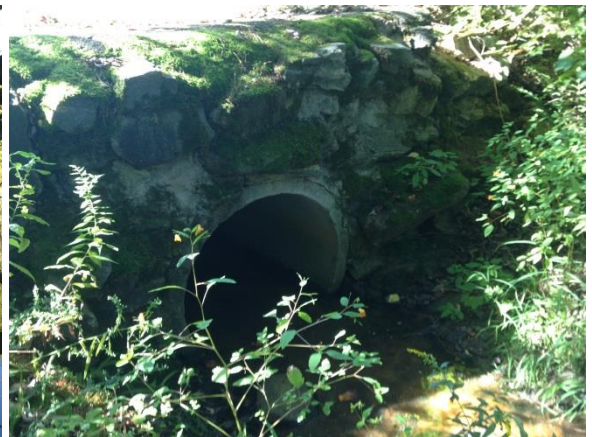
Some minor beaver activity was observed at the culvert in the form of packed mud, suggesting the creation of a new dam. More intense activity had been previously observed by the Town at the culvert, and in nearby residential yards before trapping conducted in 2012. Based on the presence of appropriate habitat, it is likely that beaver will recolonize the pond and increase damming activities. At this time, a water flow device may be required at the culvert to prevent weekly maintenance of the culvert grate.

View of Merrymeeting Road culvert.

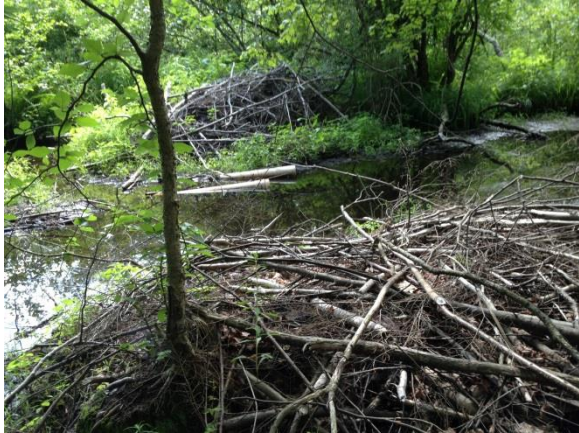
Area 20 is located near Carrie Drive and Madistone Drive, on the southern edge of the Mitchell Drive Town Forest. This area has dense residential development and has been the location of extensive beaver damming activity. Due to the low streambank slopes and adjacency of yards, the beaver dams caused flooding in residential yards and were impacting the performance of septic systems located in the area. One 40-foot long by ten foot wide breached beaver dam was located in this area as well as a series of small dams across small tributary flows.

View of inactive breached beaver dam at Area 20.

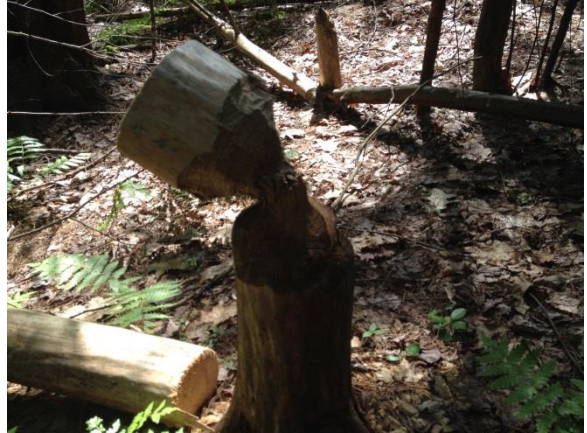
View of tree damage caused by beaver.

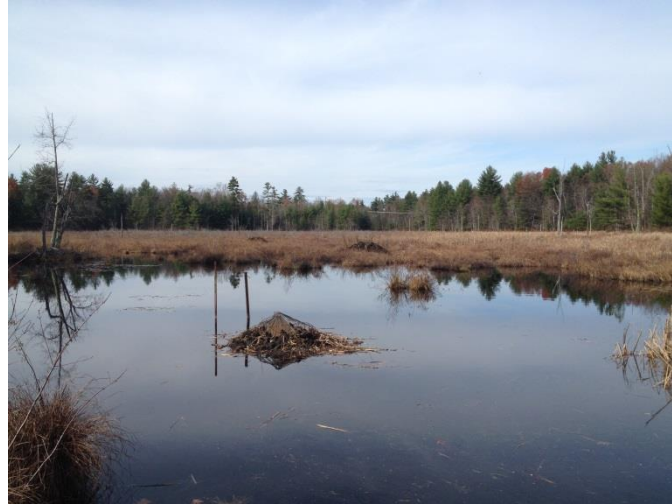
Area 22 contains a drop inlet to a culvert under Naticook Road that eventually drains to Greens Pond. The existing inlet is regularly plugged by beaver, which has resulted in road flooding in the past. The Highway Department has had to complete regular maintenance in Area 10 to maintain the road. A protective fence and water flow device was installed at this location during 2014.

View of Area 22.

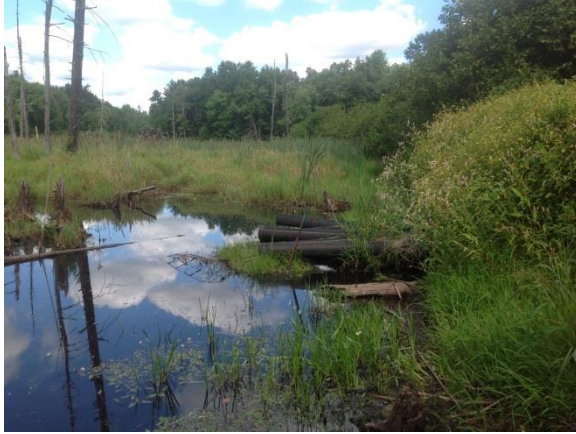
View of culverts installed on Summitt Road to prevent plugging by beaver. These limit flow and wildlife passage.

The culvert is the location of a small intermittent stream. Although beaver activity has been observed in the past, there was no new damming observed during 2014. One abandoned dam, measuring approximately five feet long by two feet wide was observed at the culvert structure. The presence of a grate and multiple pipes within the primary pipe suggests that the culvert was altered in the past to limit culvert plugging. However, the current pipe limits both wildlife passage and stream flow. If beaver activity increases in this area, a properly designed culvert fence is recommended to replace the six smaller plastic pipes in the primary culvert structure.

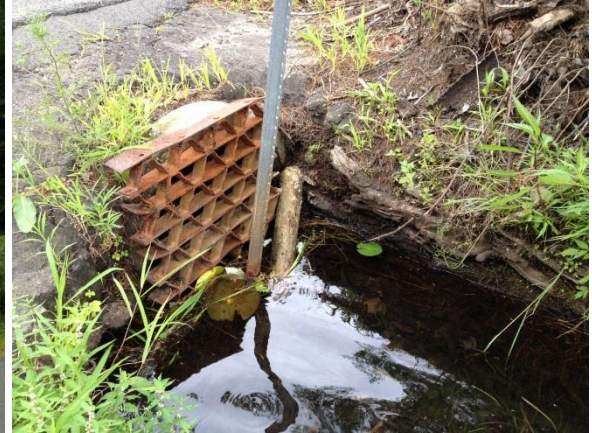
GZA observed old beaver activity at the two foot culvert and grate. However, no new dams were observed. If activity increases, a culvert protective fence in this area might serve to limit frequent maintenance and provide enhanced aquatic passage.

View of road culvert requiring period maintenance.

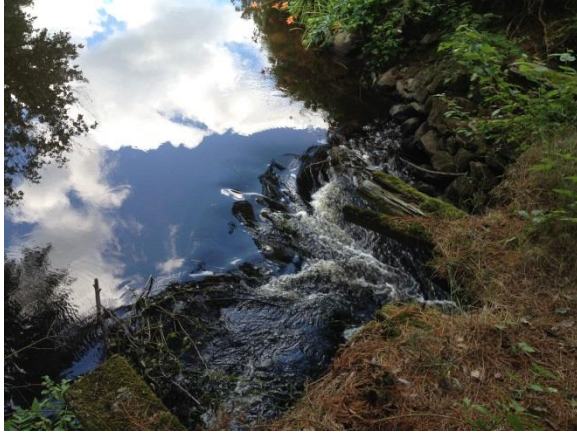
Twin Bridges consists of old stone bridge abutments. In one location, where the abutments have become dilapidated, beaver have started construction of a 25-foot long by three foot wide stick dam. Due to the steep grades in this location, and relatively far distance to nearby houses, no management is recommended in this area. Should beaver activity increase, and pose unacceptable impacts, a properly designed water flow device could be installed in the dam.

View of the start of a beaver dam at Twin Bridges.

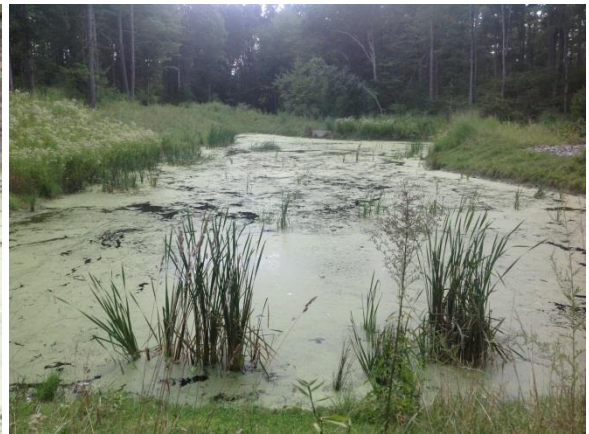
Overall view of detention pond.

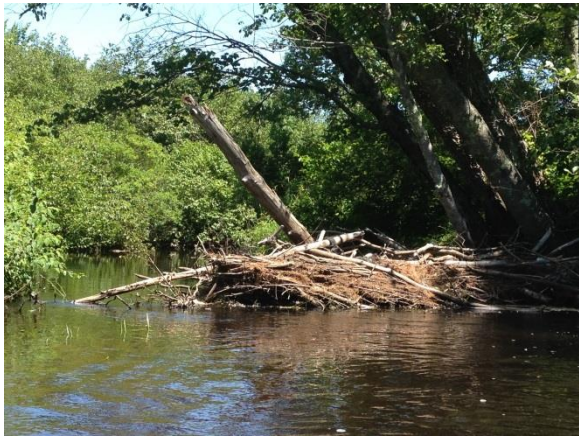
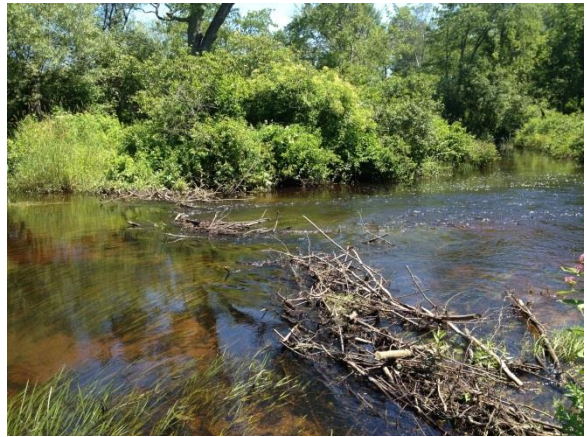
In previous years, beaver dammed the large metal culvert located at Wire Road. During 2014, no new dams were located at the culvert. However, four individual beaver dams of varying sizes were located east of Wire Road and two additional dams were observed west of Wire Road in McQuade Brook, which drains into Baboosic Brook. East of Wire Road, the dams were only partially formed, varying from 45 to 75 feet long and covered approximately 70% to 95% of the channel width of Baboosic Brook. In McQuade Brook, dams ranged from 15 to 25 feet long and covered 100% of the channel.

View of old and newly created beaver dams on Baboosic Brook.

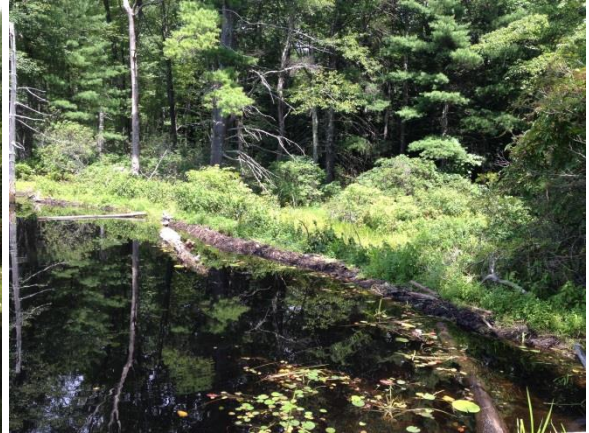
Because this is a large conservation area located upstream of additional conservation land maintained by the Town, no management activities are recommended. This area represents an ideal location in town to allow natural dynamics of beaver pond succession. The site is already used as an outdoor classroom by the nearby middle school, and the maintenance of beaver in this pond supports a variety of wildlife species.

View of beaver dam at Area 33.

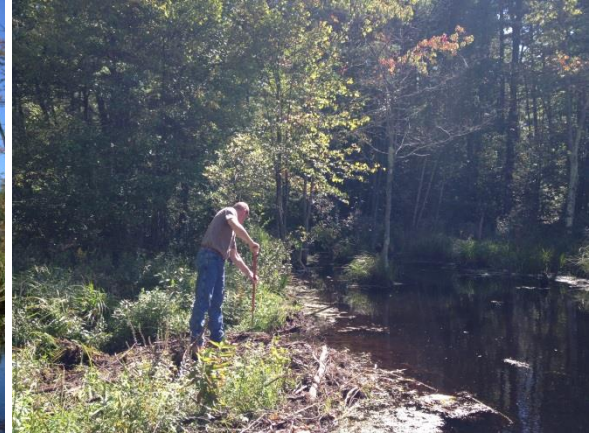
View of large beaver dam and area of old underwater culverts and associated carriage road.
