# COMPREHENSIVE BEAVER MANAGEMENT PLAN MERRIMACK, NEW HAMPSHIRE

May 15, 2015

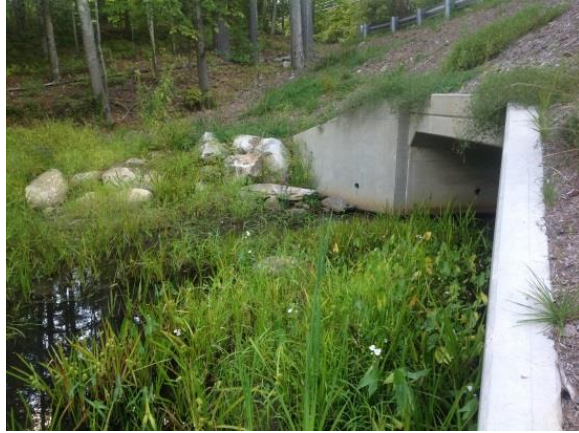
Area 1 is a culvert location on Amherst Road situated west of Meetinghouse Road. The culvert structure consists of a large 9-foot wide concrete box, and serves an unnamed perennial stream. The upstream wetland at the culvert is a wet meadow that is classified as a palustrine, emergent system that is seasonally and semi-permanently flooded (PEM1E/F). The downstream wetland consists of a forested perennial channel with an unconsolidated bottom (R2UB). Based on Town records, the crossing was more regularly dammed by beaver prior to the installation of the larger box culvert.

View of Upstream side of culvert at Area 1.

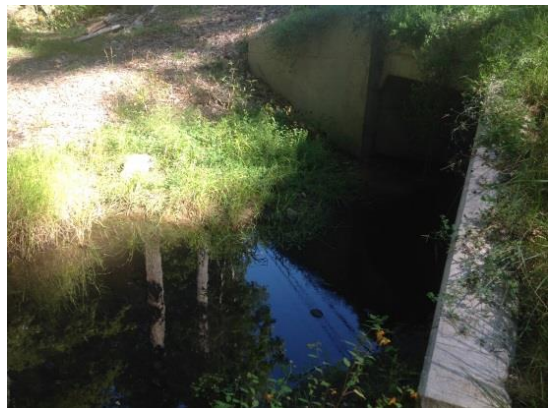
View of downstream side of Area 1 culvert.

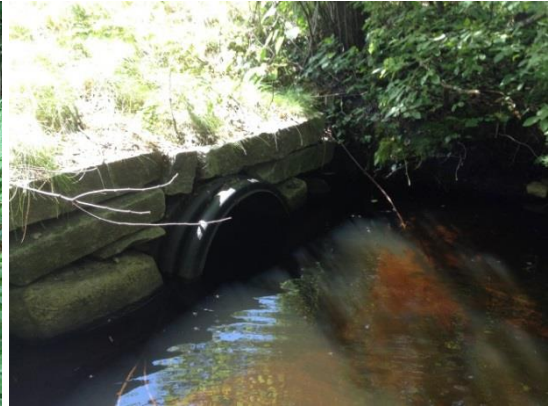
View of Area 2 culvert outlet.

Area 2 contained many tree stumps cut by beaver. Most of the stumps appeared to be older cuttings. There was no evidence of current dams, lodges, or food piles directly downstream of Area 2. However, this area is located in close vicinity to five other known problem areas, four of which exhibited recent beaver sign. Area 2 is located within a high habitat suitability area and should be monitored at least annually as part of road maintenance activities.

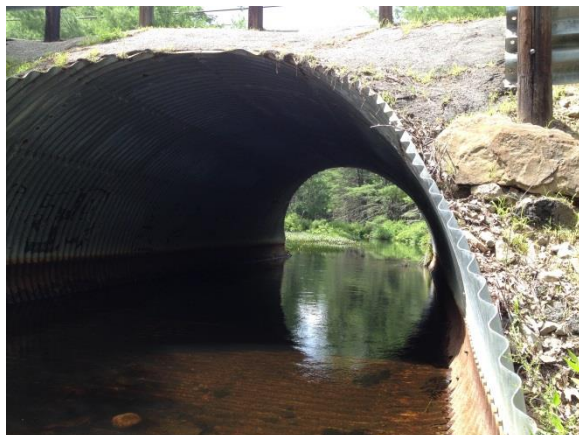
View of Area 3 looking upstream at the culvert.

Area 3 is a previous location of beaver damming activity. In addition, the site has evidence of flooding and tree damage. During 2014, there was no evidence of current damming by beaver near the culvert. However, the floodplain contained old tree cuttings created by beaver. Area 3 is located in a High Habitat Suitability Area. Although the high dominance of white pine in the area might reduce the likelihood of this area serving as a core habitat area, Area 3 is located in a stream corridor with existing beaver populations. Similar to other sites, this area should be reviewed annually to determine current beaver activity over time.

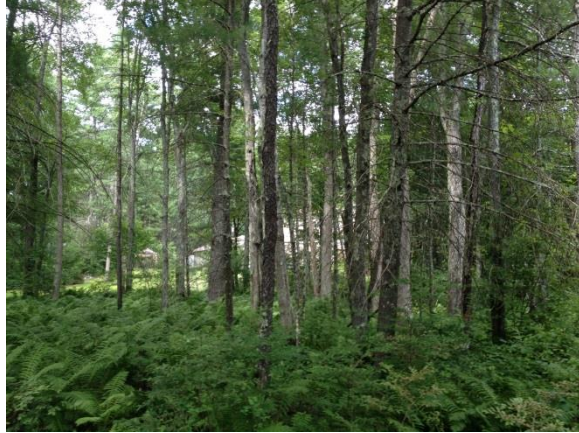
View of the low floodplain near residences.

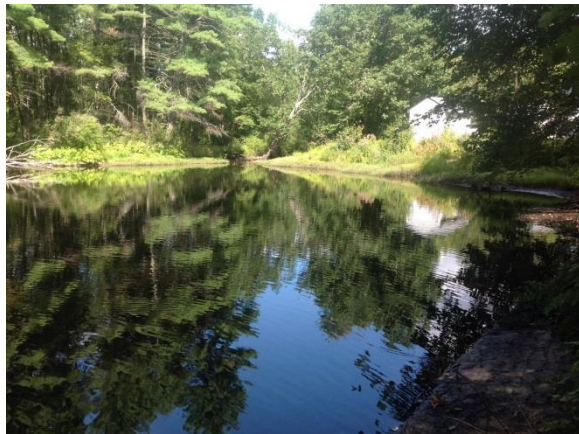
Area 5 contained a series of old beaver dams but lacked new tree cuttings or fresh mud on old dams during the summer of 2014. Based on landowner testimony, there was no obvious beaver activity in this area during the spring of 2014. Although there are no current conflicts, this area functions as a possible recolonization site.

View of Baboosic Brook at Area 5.

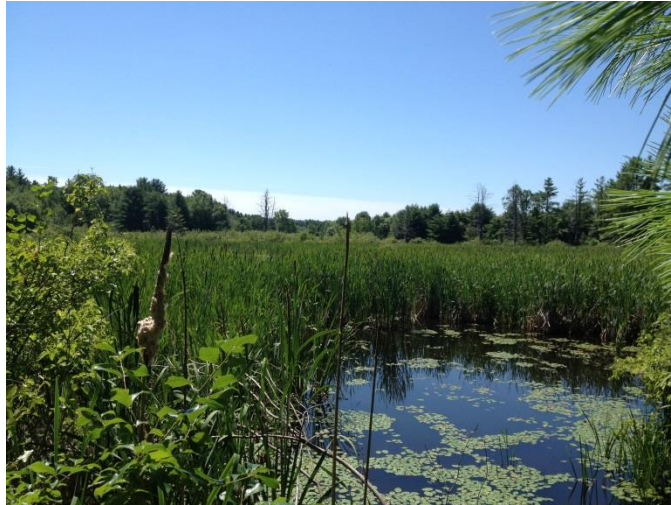
View of Beaver Pond near Level Street.

Both Area 6A and 6B had evidence of active beaver use. Multiple dams were observed near Level Street and near Cathy Street. The activity near 6A (Level Street) was not impacting nearby residences during the 2014 growing season. However, 6B is in the vicinity of a sewer manhole and a large beaver dam had flooded the manhole location during 2014.

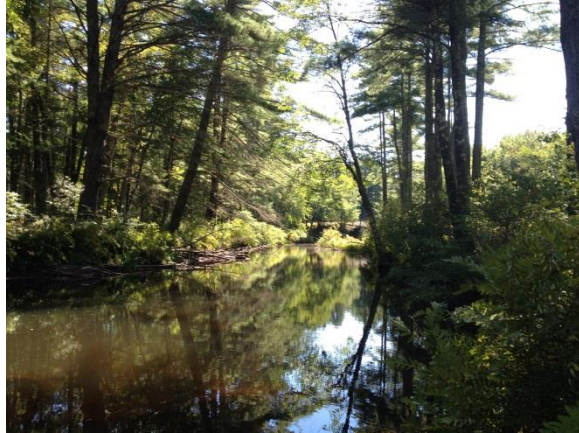
No active dam building was observed in this area. However, based on landowner testimony, numerous trees had been felled by beaver in previous years. A nearby residence had installed screening on trees to prevent beaver chewing. Although beaver activity is currently low, this area represents a potential recolonization site. During annual conservation easement monitoring, it would be advisable to conduct beaver activity monitoring at the same time.

View of brook at Area 8.

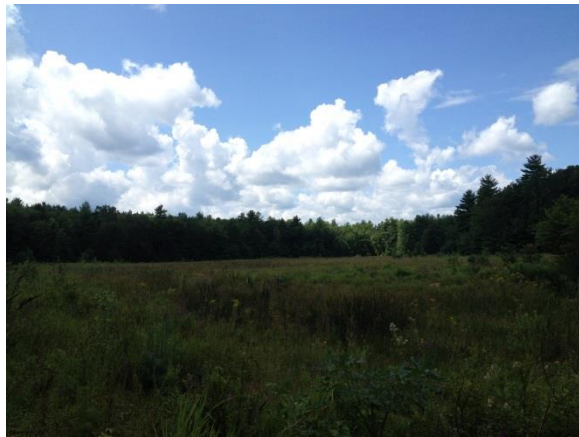
Area 9 is located in the Grater Woods Conservation Area. The area is a previous beaver pond. The failure and breaching of a small beaver dam (approximately 12-feet long by 4-feet wide) led to the complete draining of the prior pond. The area currently consists of a small stream meandering through a wet meadow. The wet meadow is classified as a palustrine emergent system that is seasonally saturated (PEM1E). The upland forest surrounding the wet meadow is dominated by white pine, in association with red maple. The dominant plant species in the herbaceous layer are wool grass, goldenrod (*Solidago* spp.), and broad-leaved cattail. Other species present include meadowsweet, false nettle, dark green bulrush, and rattlesnake grass. Small areas of yellow spatterdock and bur-reed are also present along the stream. Purple loosestrife, an invasive plant, is also present.

View of the previous beaver pond location.

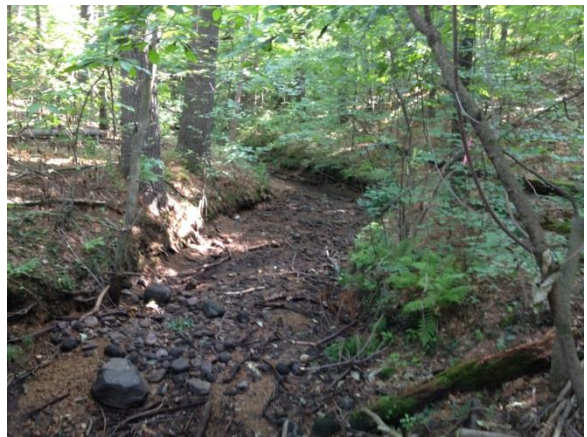
View of stream channel upstream with no flow.

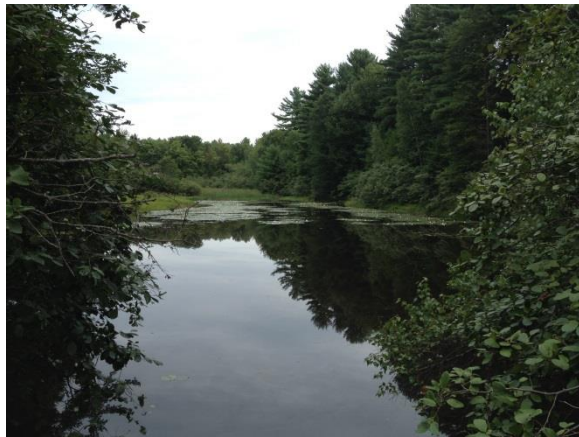
View of stormwater pond at Area 12.

Two beaver dams were documented at Area 12, including an actively maintained 5-foot long dam at the first culvert crossing and a second 10-foot long abandoned dam at the second (northerly) culvert crossing. Although abandoned, fresh beaver tracks were observed at the second crossing. At the time of the assessment, the second culvert lacked flow. Over the course of the summer, beaver activity increases at the southerly culvert crossing, which contained a grate to prevent complete damming of the culvert. This area was targeted as a potential area for a water flow device due to the weekly culvert maintenance required at this crossing.

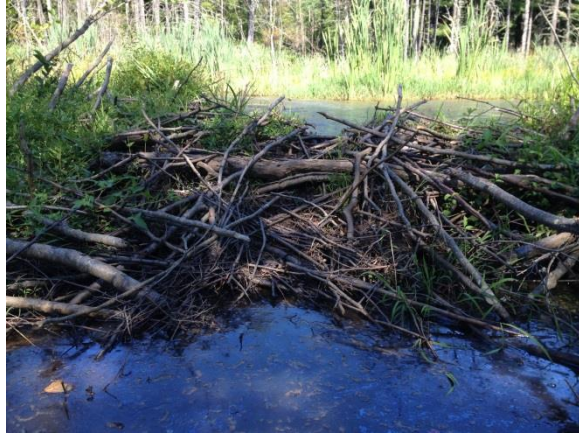
View of primary beaver dam in Area 15.

Two actively maintained beaver dams, one old dam, and one lodge and associated food pile were documented in Area 15. The longest dam measures approximately 70 feet long and was approximately 3-feet high. The second dam measured approximately 55 feet long and was up to 5-feet tall. A third older dam was located over an existing sewer easement near Continental Boulevard Extension. Area 15 had high beaver activity during 2014. The Town anticipates coordinating with nearby property owners in the future to address potential management activities in this area.

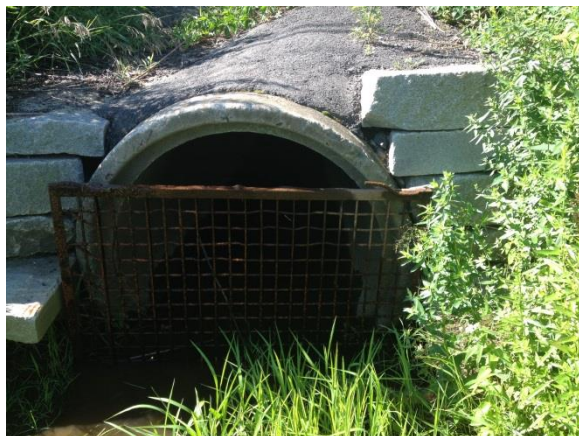
View of Lyons Road culvert and grate.

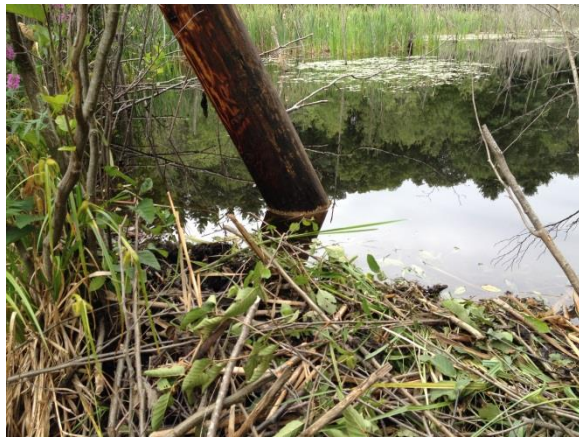
View of dam located directed adjacent to Mast Road.

Although nearby road culverts do not have signs of recent beaver activity, the presence of a beaver dam directly adjacent to Mast Road is causing flooding at a utility pole and represents a potential hazard to the road, should the dam fail. A water flow device may be necessary to control the water elevation of the pond near the road. The presence of a second channel located west of Area 17 presents another possible future conflict area.

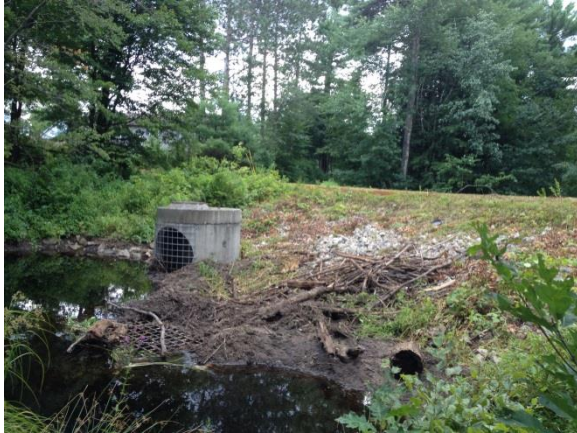
View of sewer line area looking towards Mayflower Road.

Area 18 has been the source of concern for residents bordering the pond. Dam construction by beaver has caused flooding in at least one yard, and beaver have felled large trees in adjacent yards. One owner requested immediate action to limit impacts to her property and the Dam Bureau directed the Town to prevent damage by beaver to the sewer line. Although the Town had installed a "beaver pipe" to maintain water flow in the primary dam, the pipe was routinely plugged by beaver and was not functioning. Due to landowner concerns, as well as a need to protect the sewer line infrastructure, Area 18 was considered a high priority area for management activities. A proper water flow device, as well as a protective fence for the drop inlet structure was installed at Area 18 during 2014.

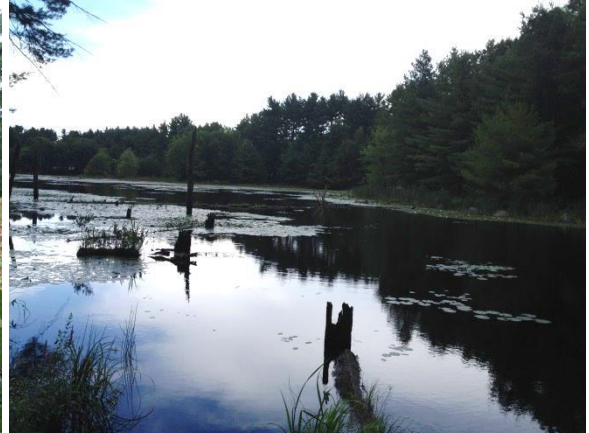
View of pond looking upstream of beaver dams.

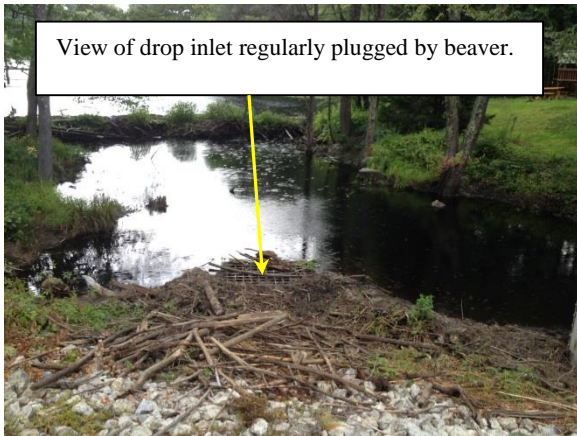
View of plugged drop inlet at sewer line.

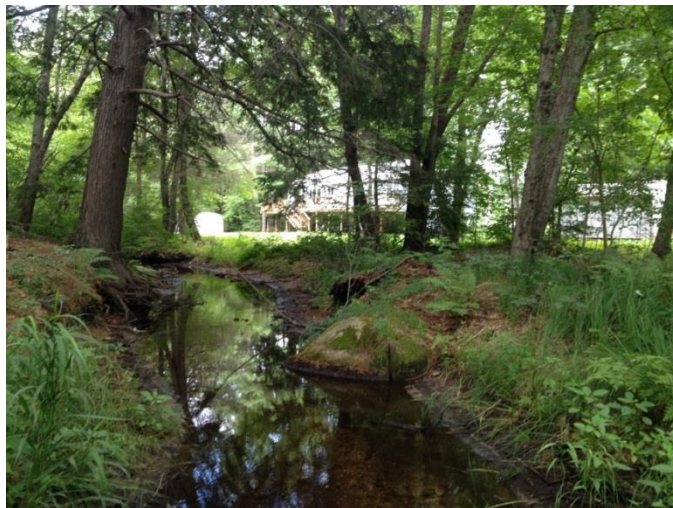
Due to the multiple conflicts with residential uses, Area 20 was heavily trapped in the fall of 2013. This resulted in relatively minimal beaver activity in the immediate area during 2014. However, due to the high habitat value of the site, it is likely that Area 20 will be recolonized by nearby colonies (e.g., Area 35) where beaver were observed during 2014. As a result, flow devices may be needed in primary beaver dams when activity increases again in this area.

View of low floodplain and close proximity of residences to Area 20.

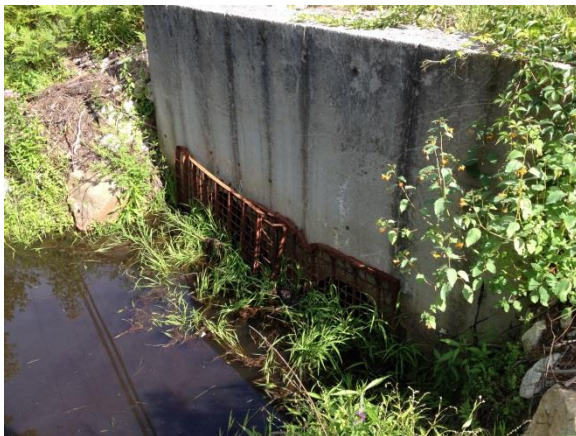
View of plugged culverts at Continental Blvd.

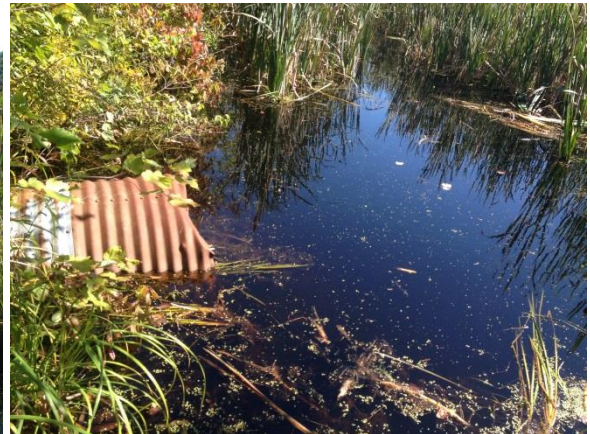
No beaver activity was observed during 2014. However, the culverts present on the road represent potential dam sites. If damming is observed in the future, culvert protective fences could be installed to prevent culvert blockage, while maintaining the important habitat features of the adjacent marsh. Any protective fences utilized in this area should be designed to provide passage to turtles.

View of culvert at Area 24.

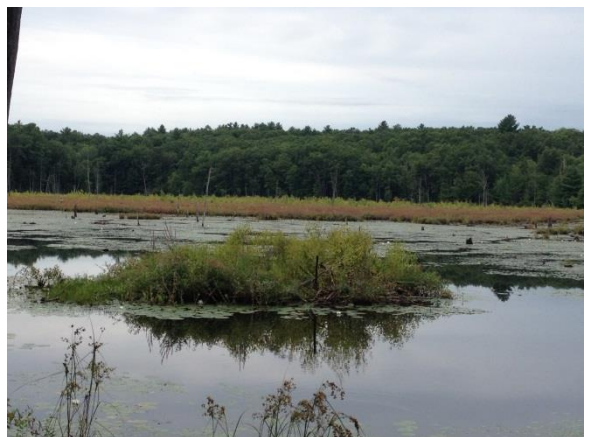
View of beaver lodge located in the marsh.

Two beaver dams and a large beaver lodge were located in the wetland. The dams varied from approximately 50 to 60 feet long and were approximately five to ten feet wide. Both dams are located in an area used for archery, and do not appear to be impacting infrastructure. However, the Queens Way residences directly border the pond and future dam activity has the potential to cause flooding in these yards. Annual monitoring may be necessary in this area.

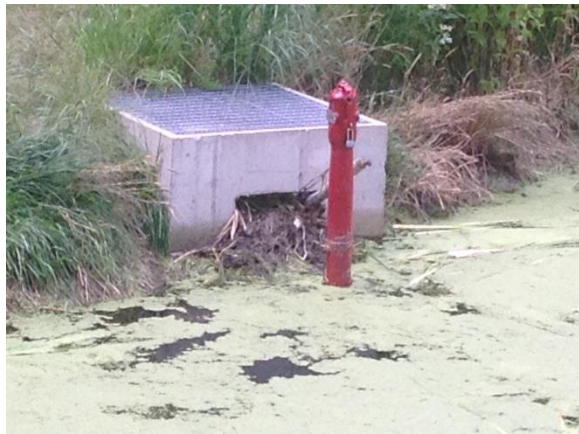
View of plugged inlet.

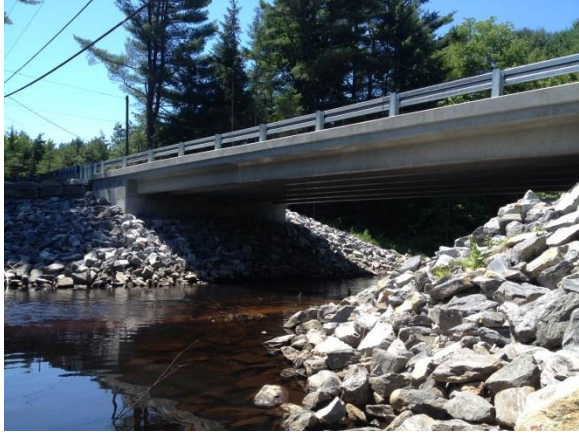
View of Wire Road Bridge.

In previous years, beaver dammed the large metal culvert located at Wire Road. During 2014, no new dams were located at the culvert. However, four individual beaver dams of varying sizes were located east of Wire Road and two additional dams were observed west of Wire Road in McQuade Brook, which drains into Baboosic Brook. East of Wire Road, the dams were only partially formed, varying from 45 to 75 feet long and covered approximately 70% to 95% of the channel width of Baboosic Brook. In McQuade Brook, dams ranged from 15 to 25 feet long and covered 100% of the channel.

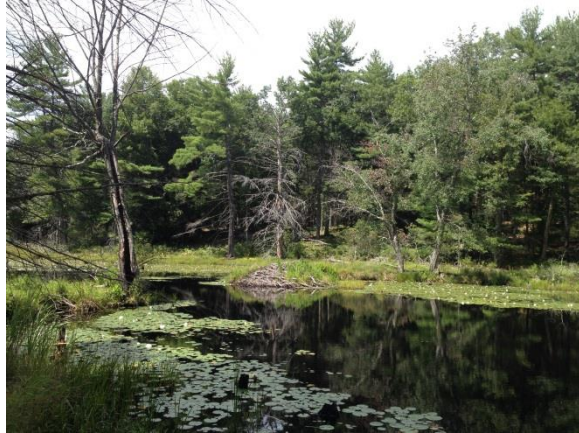
View of beaver pond and beaver lodge at Area 33.

Because this is a large conservation area located upstream of additional conservation land maintained by the Town, no management activities are recommended. This area represents an ideal location in town to allow natural dynamics of beaver pond succession. The site is already used as an outdoor classroom by the nearby middle school, and the maintenance of beaver in this pond supports a variety of wildlife species.

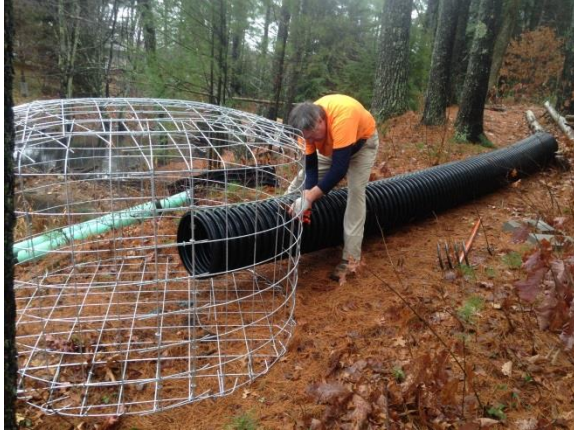
View of construction of Flexible Pond Leveler.

A Flexible Pond Leveler and 15” ADS pipe were installed in the beaver dam located upstream of the sewer line. The leveler was designed to replace a dysfunctional beaver box that was plugged and no longer functioning. Beaver Solutions LLC installed the leveler with assistance from the Town of Merrimack Highway Division. The Leveler was installed at an elevation to effectively reduce the pond level at the dam by approximately one foot. This depth reduction was designed to address private property impacts caused by

the rising pond levels, reduce flooding risks to the adjacent sewer line, and to maintain appropriate water depths in the pond to continue to support beaver. In addition, water level changes of more than one foot can be associated with an increase in damming activity by behavior, so the water level change was considered an appropriate compromise between the desire to maintain private property and municipal infrastructure, while maintaining important natural features associated with Meadowwood Pond.

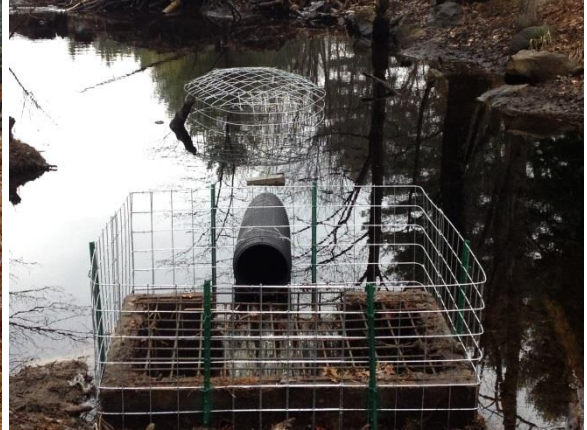
View of protective fence installed at the inlet to Meadowwoods Dam.

To limit repeated maintenance at the existing drop inlet, a fence and pipe flow device were installed at the inlet. The goal of the installation was to reduce the need for weekly maintenance by the Highway Department, and to protect water flow through Meadowwood Dam. This indirectly also serves to protect the base flows of the associated stream, which were limited by repeated damming.

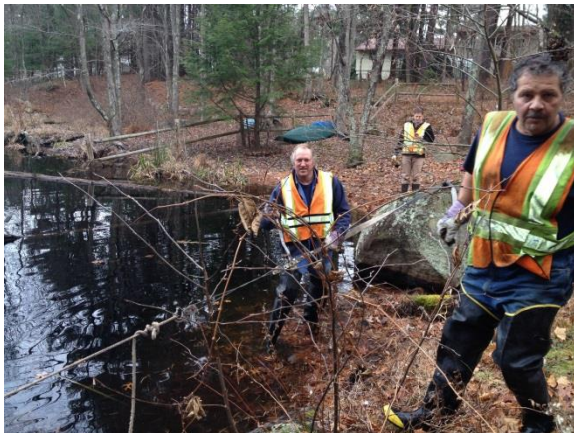
The Highway Department assisted with site preparation.

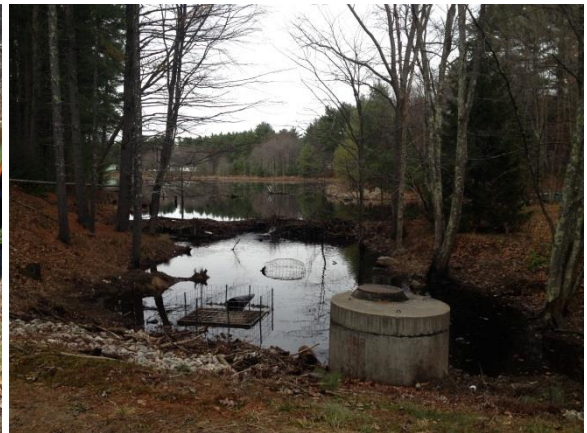
View of installed devices. The Flexible Pond Leveler in the main beaver dam is submerged.

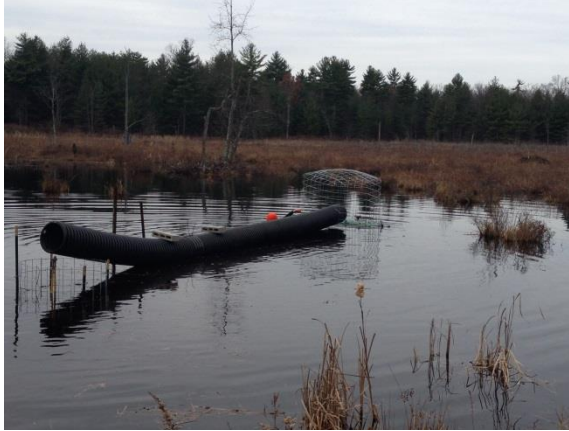
### Area 35 (Mitchell Woods)

View of Flexible Pond Leveler prior to submersion.

extension and exclusion fence was also installed at the outlet of the leveler to provide protection of the flow device at the outlet, where reduced water depths were present. The devices were installed at a height in the dam to achieve an approximately one foot drop in the pond level. During installation, old culverts were discovered buried in the beaver dam, above the elevation of an old carriage road. The intent of the devices was to avoid the constant need for maintenance of the beaver dam to limit impacts on residents. Town volunteers were conducting weekly maintenance evaluations of the dam in the conservation area to assess impacts to nearby residents.

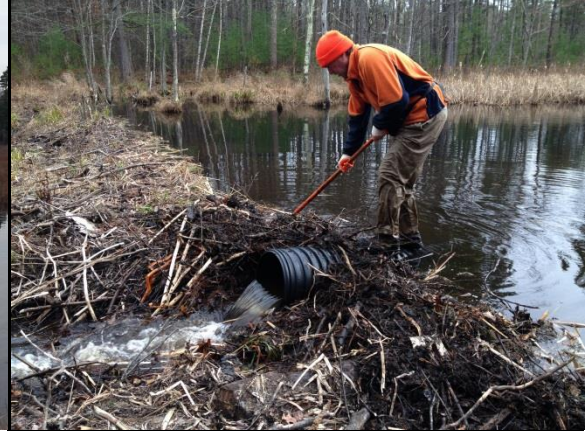
View of pipe outlet installed in beaver dam.

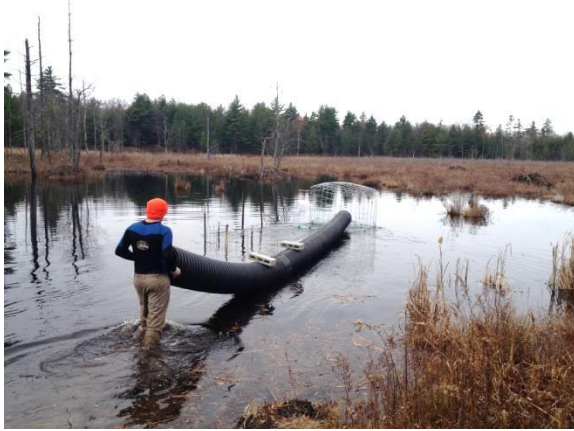
#### Area 22 (Naticook Road)

Area 22 contains a submerged drop inlet that is repeatedly plugged by beaver. The drop inlet connects to a culvert under Naticook Road that provides hydraulic connectivity to a stream. When not maintained, the plugging of the drop inlet results in flooding of Naticook Road. Beaver Solutions, LLC installed a culvert protective fence and pipe device at the drop inlet, consisting of a Flexible Pond Leveler pipe system and 15-inch pipe connected to the fence protecting the drop inlet. The inclusion of the Flexible Pond Leveler pipe system allows beaver to dam at the drop inlet while still allowing flow through the leveler pipe. Water flow was restored to the drop inlet at the completion of construction of the pipe and fence system.

View of Constructed Flexible Pond Leveler just prior to installation at the drop inlet.

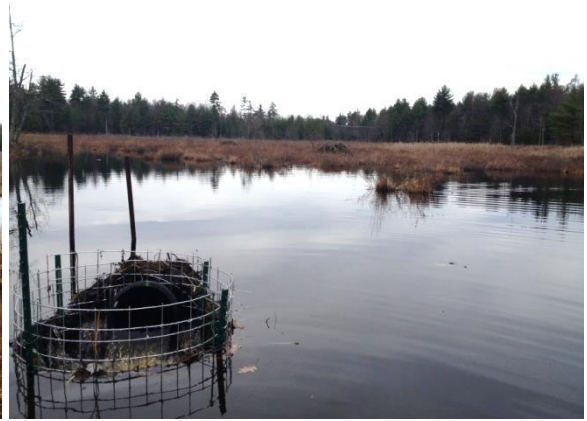
View of protective fence and outlet of the Flexible Pond Leveler at the drop inlet after installation.

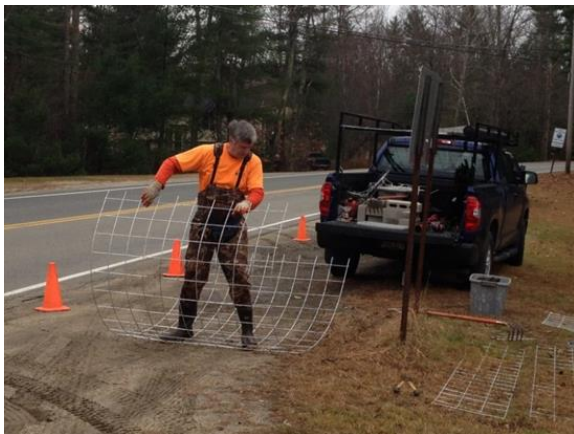
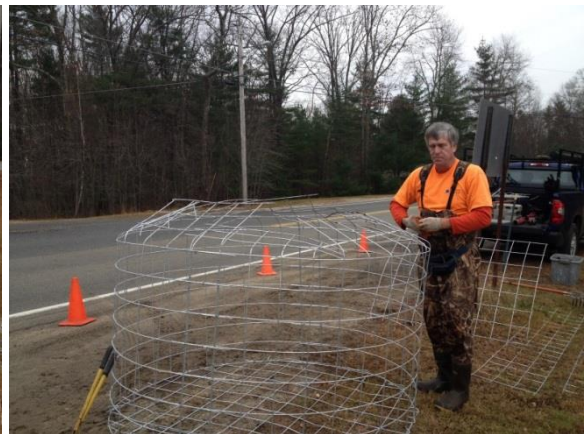
Six gauge steel panels are used to construct protective panels. The panels are cut, rolled, and bent to form an approximate 5.75 foot wide and 3.75 foot wide protective fence to surround the inlet of an HDPE pipe.

High Density Polyethylene (HDPE) Pipe (15-inch) was obtained by ADS. Double-walled pipe was selected to provide additional protection from chewing by beaver. To insert the pipe, 1.5 ft. wide by 1.5 ft. tall openings are cut in the base of the fence. A few holes are drilled into the pipes to allow gases to escape and the pipes are weighed down with small concrete blocks.
